# RICS Home Survey Report

Flat C, Sample Street, London (a fictional sample property)

SAMPLE-L2PLUS

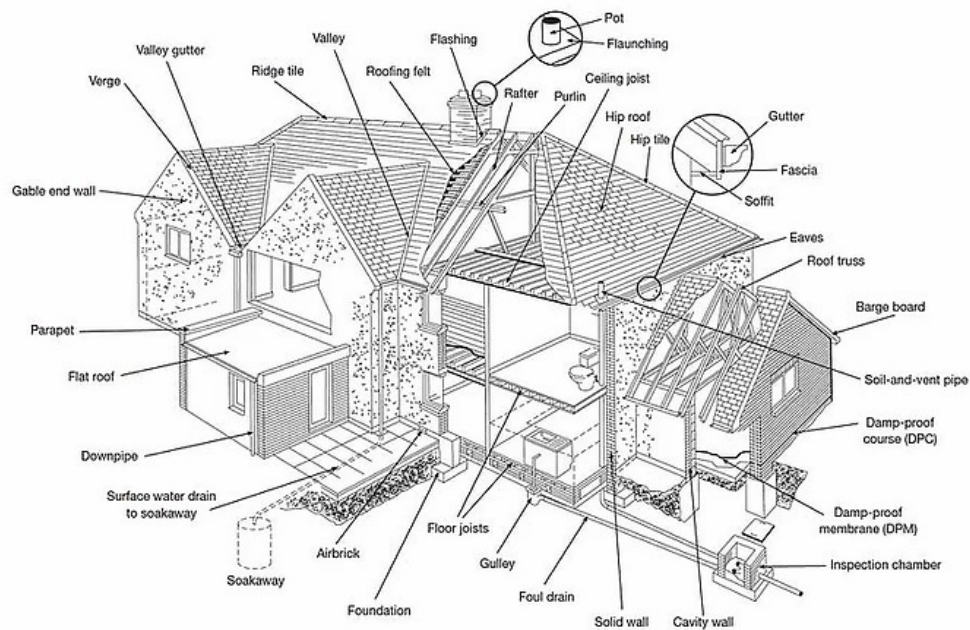
## Typical house diagram

This diagram illustrates where you may find some of the building elements referred to in the report.
